Manhole Inspection Summary

Manhole # S33UU1005MH

Location Address: **220 GOODALE RD**

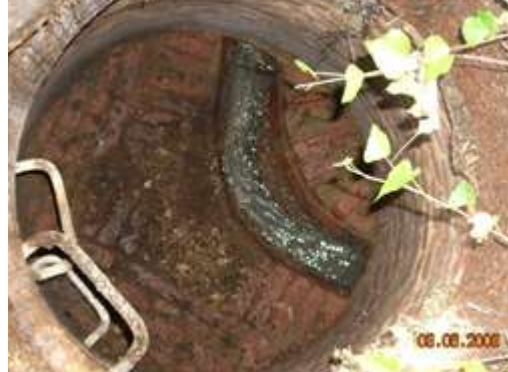
Top View

Surcharge ☒ **Evidence Of Surcharge** Depth: **1** (ft.) ☐ Active Surcharge Present

Evidence of surcharge - Bench debris.

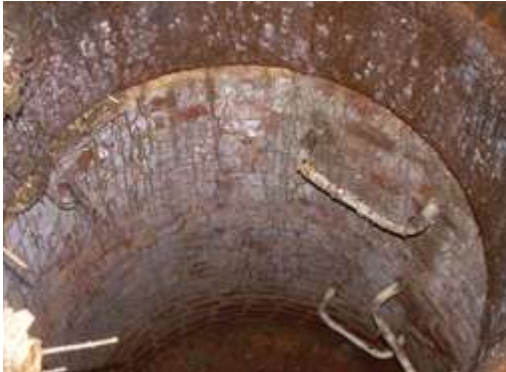
Defect

Frame Offset: **0** (in.) Condition: ☐ Sound ☐ Cracked ☒ **Leaks**

Condition: ☐ Sound ☐ Cracked ☒ **Root Intrusion** ☐ Loose Brick ☒ **Deteriorated**

Infiltration: ☐ None ☒ **Joint** ☐ Cracks ☒ **Mortar** ☒ **Roots** ☒ **Wall**

Frame leaks. Adjustment deterioration, root intrusion and infiltration. - other side.

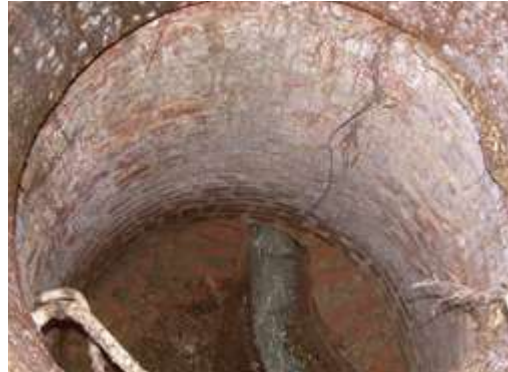
Defect

Frame leaks. Adjustment deterioration, root intrusion and infiltration.

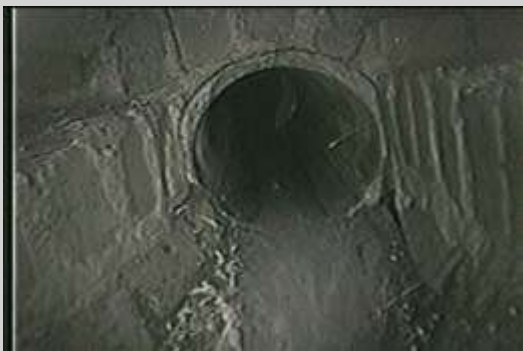
8 in. Circular Gravity Sewer Pipe In @ 4 O'Clock

Condition: ☐ Sound ☐ Cracked ☒ **Root Intrusion** ☐ Deteriorated ☐ Leaks ☐ Debris

Channel root intrusion.

Infiltration: **Evidence** Pipe Seal Cond: **Unknown**
